# Influence of Steel Bars in Detection of Voids in Concrete Using Ultrasonic Pulse-Echo Method

by Leonel Lipa, Laura M. Navarro, and Enrique N. Pasquel

*ACI Materials Journal*, V. 116, No. 4, July 2019.

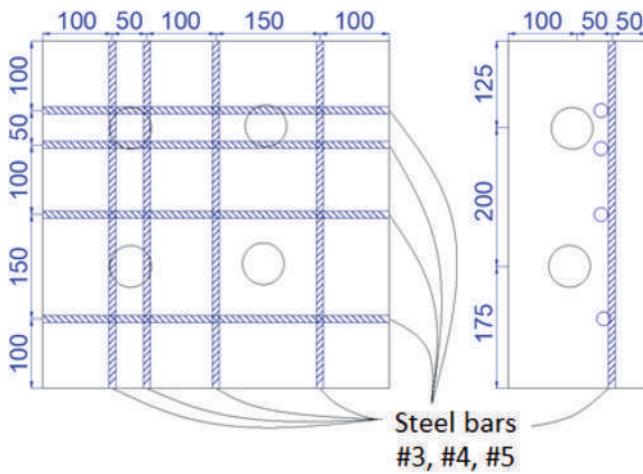
*Fig. 1—Model 1, reinforced concrete walls: (a) front view; and (b) lateral view. (Note: Units in mm; 1 mm = 0.0394 in.)*

Fifteen reinforced concrete walls with dimensions of 500 x 500 x 200 mm (19.69 x 19.69 x 7.87 in.) were made in accordance to ASTM C192.<sup>19</sup> These were divided into three groups of five walls. Each group had different diameter reinforcement, with No. 3, No. 4, or No. 5 bars. In addition, each group had two Model 1 walls, two Model 2 walls, and one Model 3. Model 1 and 2 walls had four spheres of expanded polystyrene, 50 mm (1.97 in.) in diameter, with different interior distribution, and Model 3 was a block without spheres (refer to Fig. 1 to 4). In each wall, the spheres were

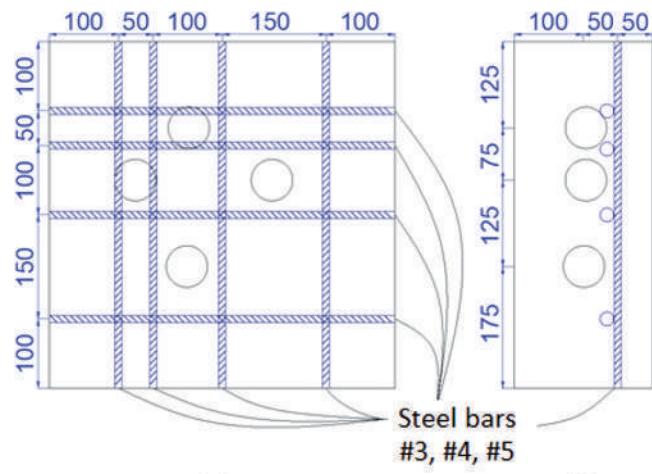
*Fig. 2—Model 2, reinforced concrete walls: (a) front view; and (b) lateral view. (Note: Units in mm; 1 mm = 0.0394 in.)*

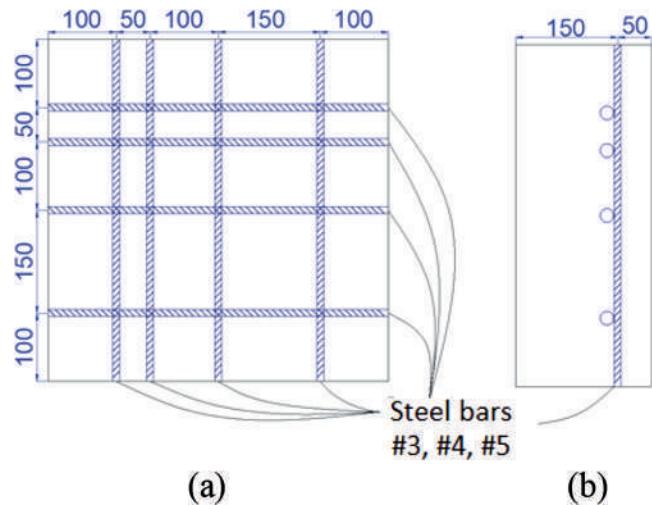
*Fig. 3—Model 3, reinforced concrete walls: (a) front view; and (b) lateral view. (Note: Units in mm; 1 mm = 0.0394 in.)*

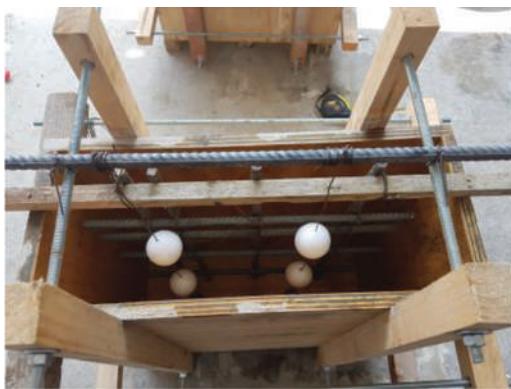
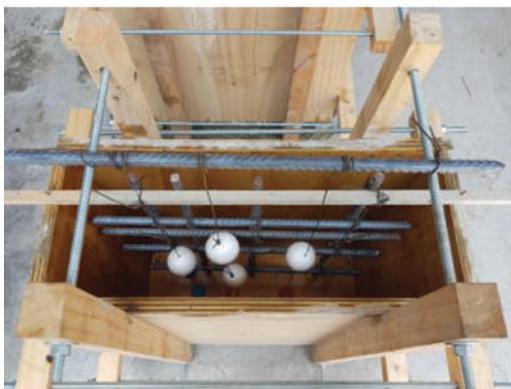
Fig. 4—Concrete walls: (a) Model 1; and (b) Model 2.

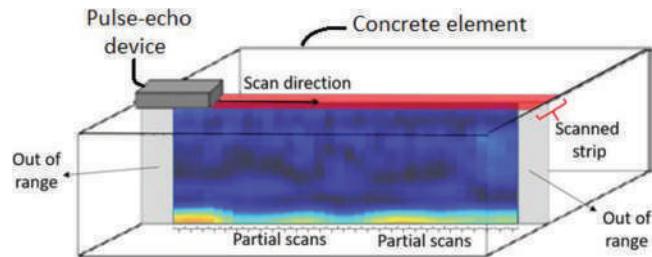
Fig. 5—Ultrasonic scan.

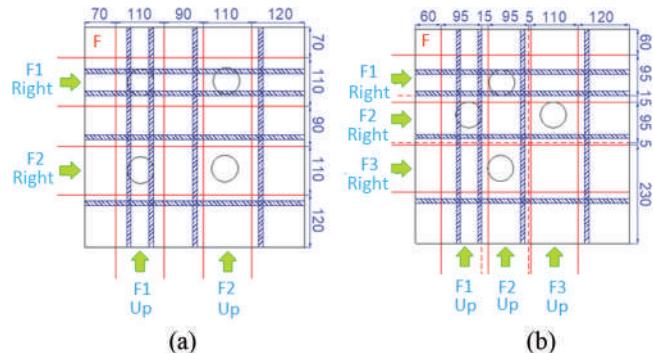
Fig. 6—Horizontal and vertical scans, Face F: (a) Model 1; and (b) Model 2. (Note: Mesh depth is 50 mm; units in mm; 1 mm = 0.0394 in.)

The walls were scanned on both sides of 500 x 500 mm (19.69 x 19.69 in.). The face where the steel mesh was at a depth of 50 mm (1.97 in.) was called Face F, and the opposite face where the mesh was at a depth of 150 mm (5.91 in.) was called Face G. Each face was scanned in horizontal (from left to right) and vertical strips (upward) in areas where the expanded polystyrene spheres had been placed. Model 1 was scanned in two horizontal and two vertical strips, Model 2 in three horizontal and three vertical strips, and Model 3 was scanned in the same way as Model 1, as well as Model 2 (refer to Fig. 6 and 7). In all scans, the

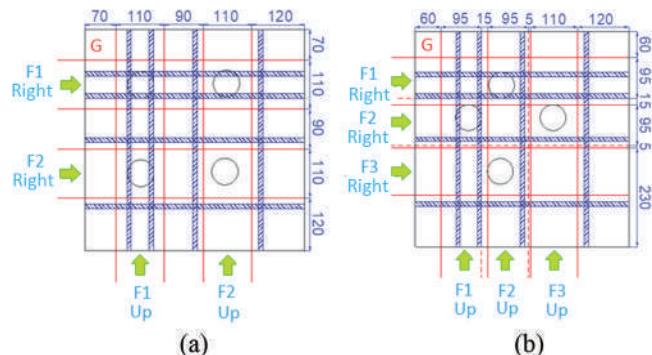
Fig. 7—Horizontal and vertical scans, Face G: (a) Model 1; and (b) Model 2. (Note: Mesh depth is 150 mm; units in mm; 1 mm = 0.0394 in.)

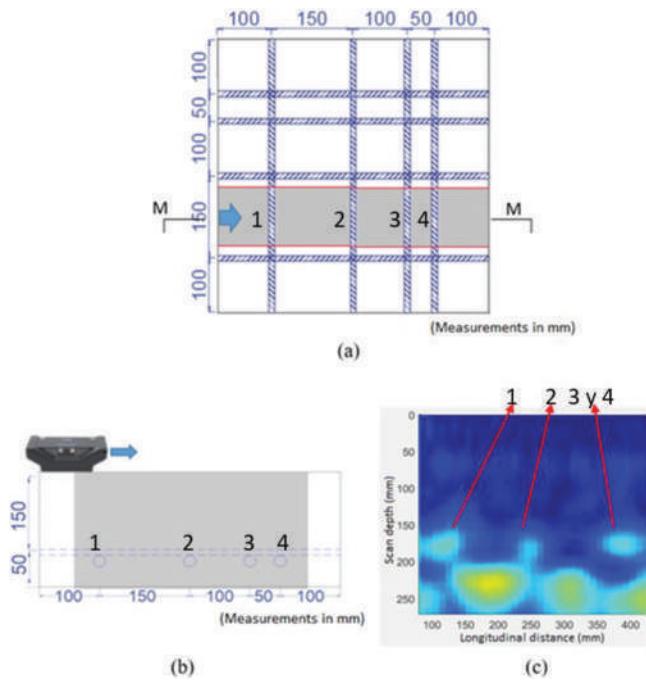
Fig. 8—Influence of No. 4 transverse steel bars: (a) front view; (b) M-M view; and (c) ultrasound scan. (Note: 1 mm = 0.0394 in.)

As shown in Fig. 8, the steel bars transverse to the scanned strip were shown as spots in the scan, which can be mistaken as voids or other material if it is not certain that they are steel bars. In addition, in this case it was observed that the transverse No. 3 and No. 4 steel bars, spaced 50 mm (1.97 in.), appeared as a single spot in the ultrasound image.

Table 1 shows the probability of finding transverse steel bars (how many times they appeared in the ultrasound images). In this table, it can be seen that the transverse steel bars are not 100% detected and if they are smaller diameter, the possibility of detection is lower. Table 2 shows the probability of finding transverse steel bars according to their depth: 50 or 150 mm (1.97 or 5.91 in.). In Table 2, for each diameter, 100% represented only the steel bars found in Table 1. Table 2 shows that when the transverse steel bars are at a depth of 150 mm (5.91 in.), detection probability with ultrasound equipment is greater than when they are at a depth of 50 mm (1.97 in.). For this analysis, the transverse steel bars separated 50 mm (1.97 in.) have not been considered because they tend to appear as a single spot in the image (as in the case of Fig. 8).

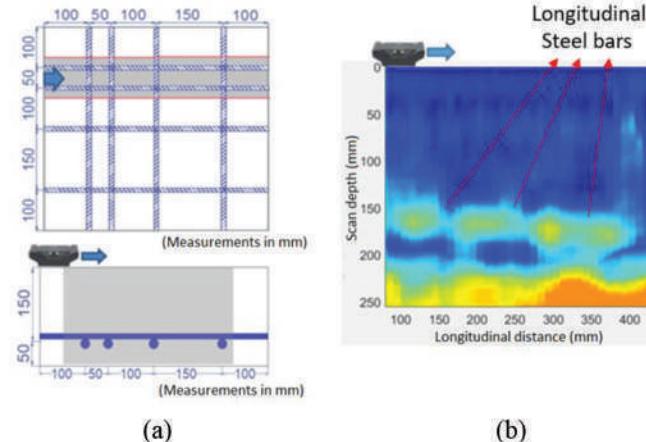
Fig. 9—Influence of No. 5 longitudinal steel bars spaced 50 mm: (a) scanned element; and (b) ultrasonic scan. (Note: 1 mm = 0.0394 in.)

When the steel bars are in the same direction as the scanned strip, they can appear as a continuous spot or as fragments, so it is difficult to distinguish if there is a void or other element within the analyzed strip. Figure 9 shows an example of how the longitudinal steel bars can be seen parallel to the scanning direction, when two bars are spaced 50 mm (1.97 in.). As shown in this image, the two bars appear as a continuous spot at a depth of 150 mm (5.91 in.), which makes it very difficult to differentiate other elements in this scan; for instance, the transverse steel bars are not detected.

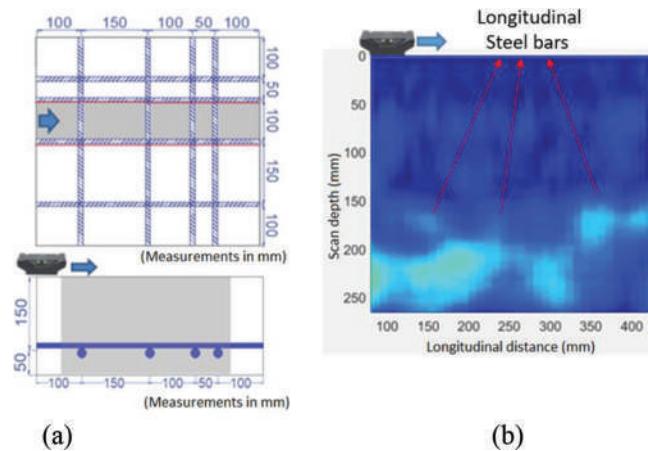
Fig. 10—Influence of No. 5 longitudinal steel bars spaced 100 mm: (a) scanned element; and (b) ultrasonic scan. (Note: 1 mm = 0.0394 in.)

On the other hand, Fig. 10 shows the case of longitudinal steel bars parallel to the scanning direction, when two bars are spaced 100 mm (3.94 in.). As shown in this image, the two bars appear as a spot of less intensity than the bars spaced 50 mm (1.97 in.). Although this spot is tenuous, the possibility to make a mistake considering them to be honeycombs or internal elements is high if there is no certainty that they are steel bars.

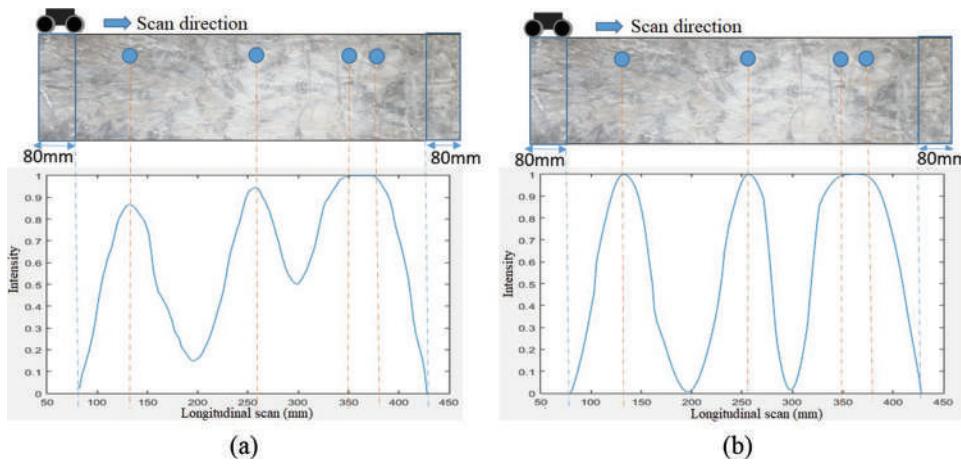
Fig. 11—Profometer signal – MATLAB: (a) without processing; and (b) processed.

scanned with the ultrasonic pulse-echo device. The idea was to use the profometer signal as an experimental empirical filter in the ultrasound image.

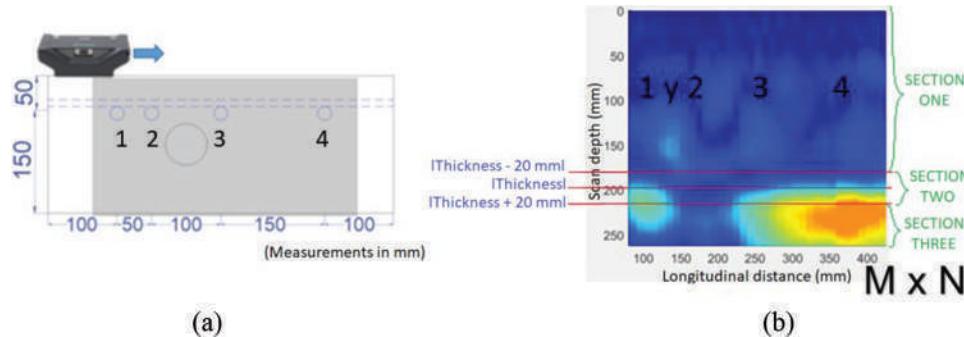
Fig. 12—Sections for filtering in a concrete wall with No. 4 steel bars: (a) scanned element; and (b) ultrasonic scan. (Note: 1 mm = 0.0394 in.)

Each ultrasound image was filtered in three row sections. Section one is from the first row to the row where the "Thickness – 20 mm" is found, Section two from the "Thickness – 20 mm" row to "Thickness + 20 mm" row, and Section three from the row "Thickness + 20 mm" up to the last row (20 mm = 0.79 in.). Figure 12(a) shows the scan of a concrete element, and Fig. 12(b) presents the obtained image of the scan, where the three sections mentioned in the ultrasound image M x N are shown (colormap: jet). In this example, the thickness element is 200 mm (8 in.): Section one is from Row 1 to the row that has a depth of 180 mm; Section two, from the 180 mm depth row to the one 220 mm; Section three, from the 220 mm depth row to the final row of the ultrasound image.

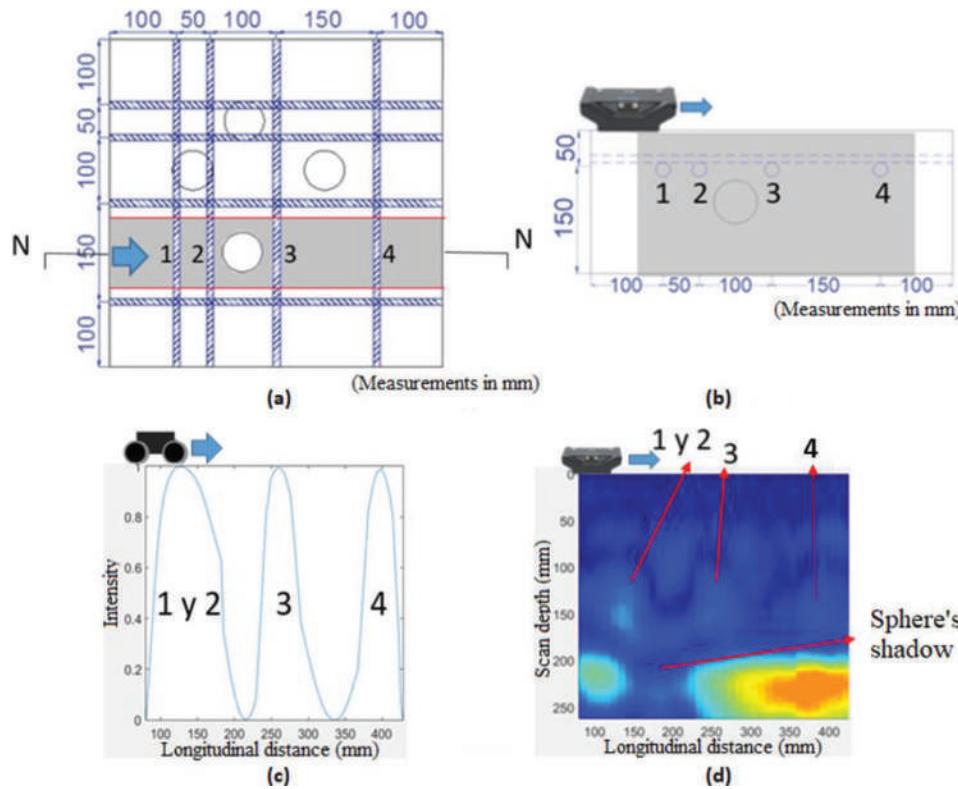
Fig. 13—Filtering example in a concrete wall with No. 4 steel bars: (a) front view; (b) N-N view; (c) profometer scan; and (d) ultrasonic scan. (Note: 1 mm = 0.0394 in.)

Two filters were used for the ultrasound images. For Section one, Filter 1 was used; for Section three, Filter 2; and for Section two, a combination of Filters 1 and 2 was used. To better understand these filters, the scan of Fig. 13 is used as example. In this image of the ultrasound scan, it can be seen that the first two transverse bars appear as a single

spot, the sphere leaves a shadow on the thickness (it does not appear as a spot), the third bar appears as another spot, and the fourth bar as a faint spot.

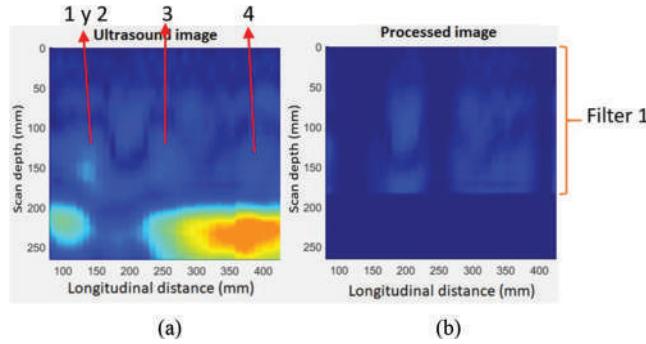
Fig. 14—Filter 1: Section one: (a) ultrasonic scan; and (b) processed image, section one. (Note: 1 mm = 0.0394 in.)

a) *Filter 1: Section one*—This filter reduces the spots left by the transverse steel bars of the ultrasound image. For this, each row “1 x N”, “2 x N”, ..., “[Thickness – 20 mm] x N” is

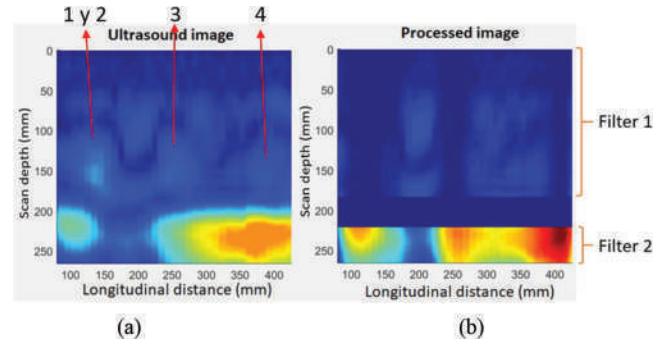
Fig. 15—Filter 2: Section three: (a) ultrasonic scan; and (b) processed image, section one and three. (Note: 1 mm = 0.0394 in.)

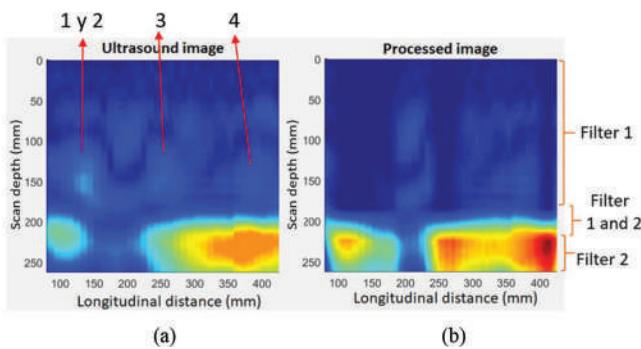
Fig. 16—Filters 1 and 2: Section two: (a) ultrasonic scan; and (b) processed image, section one and three. (Note: 1 mm = 0.0394 in.)

of Filters 1 and 2 is performed between rows [Thickness – 20 mm] and [Thickness + 20 mm]. In Fig. 16(a), the image obtained with the equipment is shown and in Fig. 16(b), the image has been completely processed. As shown in the latter, in Section two, a combination of Filters 1 and 2 is applied so now there is continuity between Sections one and three. Figure 16(b) shows the ultrasound image without spots and openings from the steel bars, and only the opening left by the 50 mm (1.97 in.) diameter sphere can be seen.

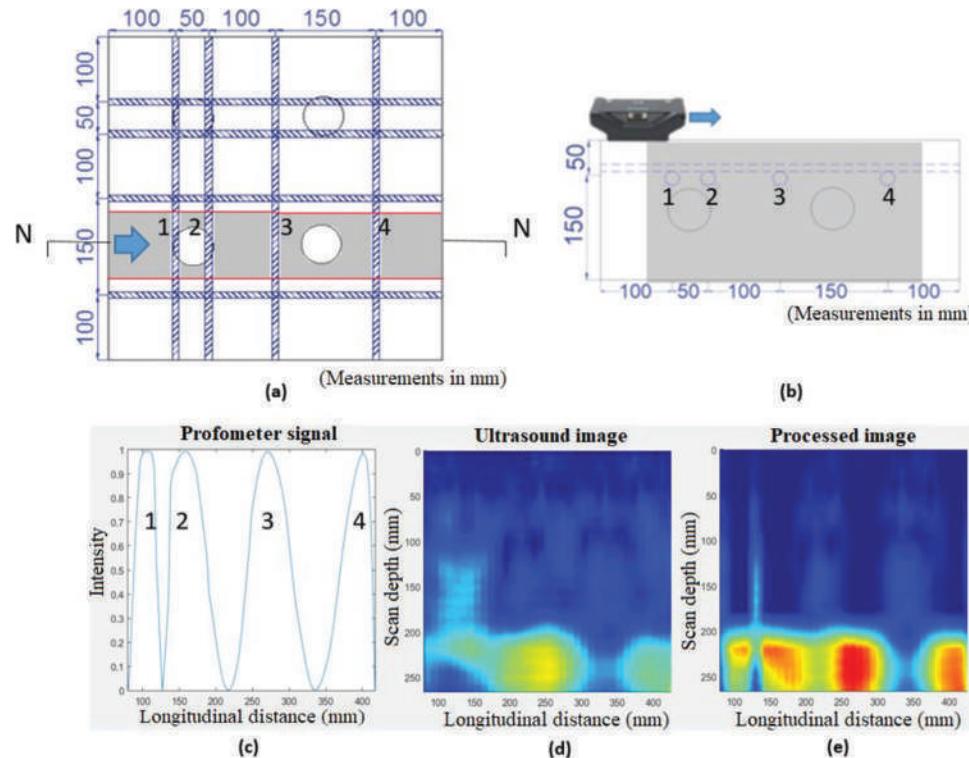
Fig. 17—Filtering example in concrete wall with No. 5 steel bars: (a) front view; (b) N-N view; (c) profometer scan; (d) ultrasound image; and (e) processed image. (Note: 1 mm = 0.0394 in.)

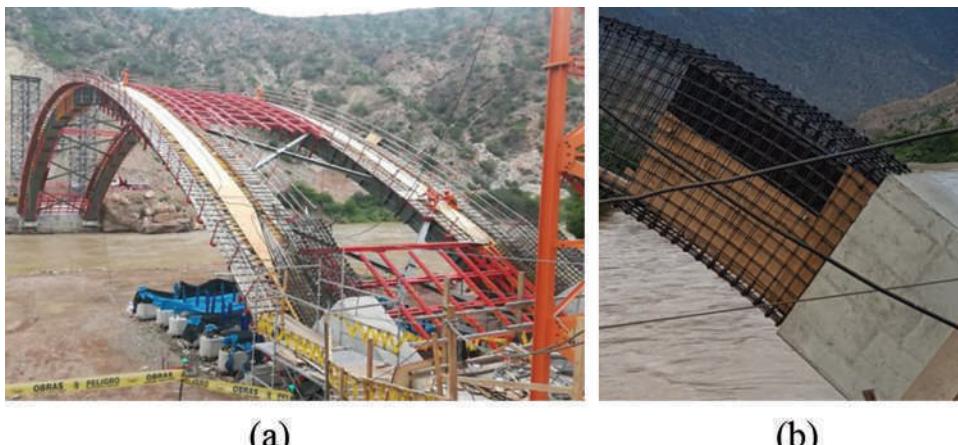
Fig. 18—Bridge in construction: (a) global view; and (b) Springer arch.

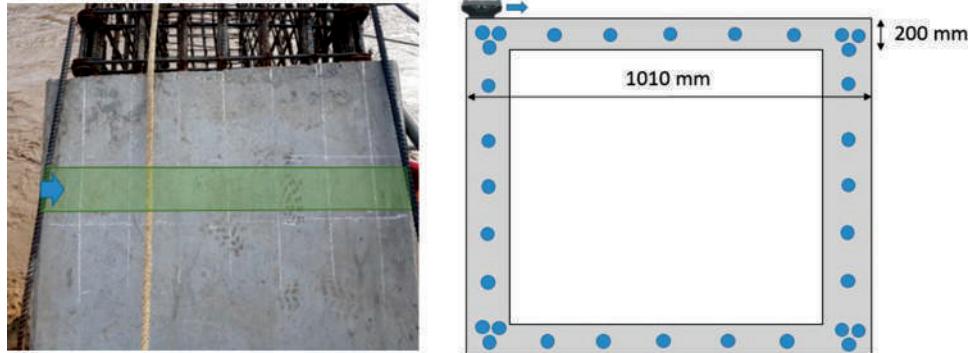
Fig. 19—Scan of springer arch (No. 4 steel bars): (a) top view; and (b) front view.

meter. In Fig. 19(a), the springer arch is shown, and in Fig. 19(b), the cross section of the arch. Figure 20 shows the profometer signal, the ultrasound image obtained, and the image already processed of a scanned strip on the top face. In this case, the spots caused by the steel bars were almost completely removed; however, when the shadows of the steel bars were filled, an area (red circles in the image) was not completely done. Therefore, it is likely that there are internal or empty elements in this area of the concrete element. In this structure, there were internal steel hooks and, because the openings in Fig. 20(c) are small, it is possible that these are hook shadows that the profometer could not detect.

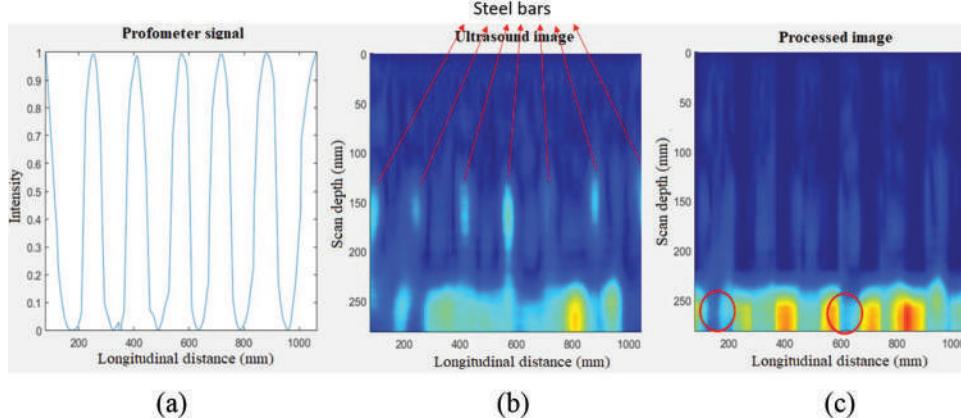
Fig. 20—Ultrasonic scans of bridge: (a) profometer signal; (b) ultrasonic image; and (c) processed image. (Note: 1 mm = 0.0394 in.)

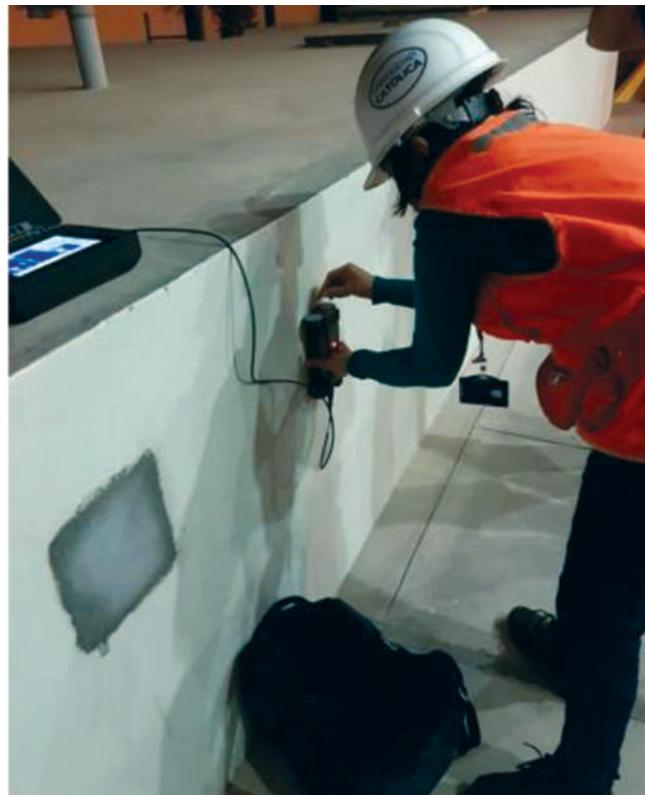
Fig. 21—Wall scan of cistern.

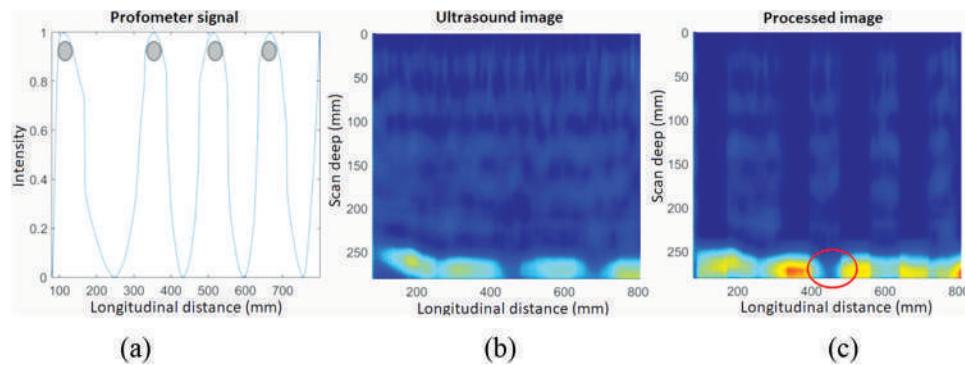
Fig. 22—Image processing of wall scan: (a) profometer signal; (b) ultrasonic image; and (c) processed image. (Note: 1 mm = 0.0394 in.)

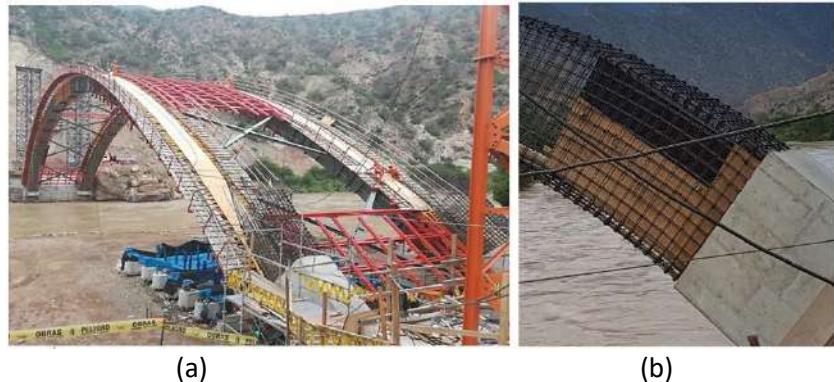
Figura 18: Arranques del puente en construcción.  
(a) Vista global (b) Vista de un arranque

The bridge studied is located in Chacanto, Cajamarca, Peru, and was under construction (Fig. 18). The scanning of the bridge's springer arch was carried out using the pulse-echo and profometer devices. In this case, it was necessary to check if there were internal voids in the concrete elements.

El puente en estudio está localizado en Chacanto, Cajamarca, Perú y se encontraba aún en construcción (véase figura 18). El escaneo de los arranques del puente fue realizado por medio de un equipo de ultrasonido y detector de metales. En este caso se quería verificar si existían cangrejeras internas en los elementos de concreto.

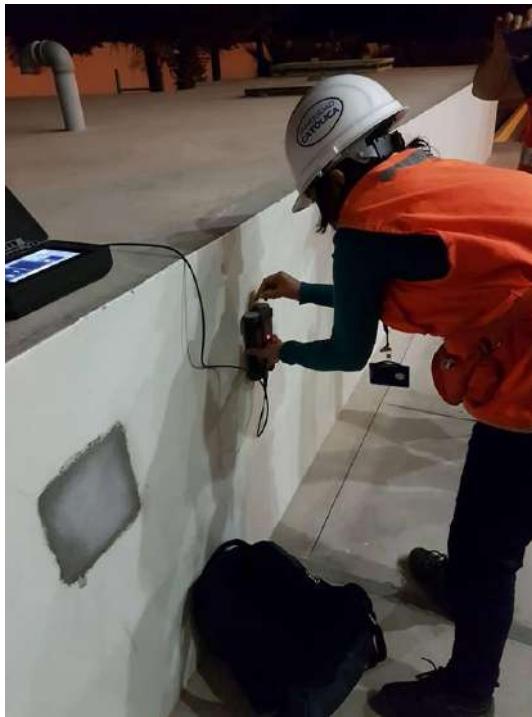
Figura 21: Escaneo de cisterna.

A perimeter wall of a cistern was scanned in Tacna, Peru, to verify the existence of internal voids in the concrete element (refer to Fig. 21). The wall had a thickness of 250 mm (9.84 in) and No. 4 steel bars. Figure 22 shows the scanning and processing performed on a portion of the cistern perimeter wall. In Fig. 22(b), the steel bars appear like openings in the ultrasound image. However, when the image is processed, all shadows disappear except for one (refer to Fig. 22(c)). This perimeter wall had a double steel mesh so the profometer equipment only detected the mesh closest to the analysis face and not the rear one.

Por otra parte, se realizó el escaneo de una cisterna de un muro perimetral en Tacna, en el cual también se quería verificar la existencia de vacíos internos en el elemento de concreto (véase figura 21). El muro tenía un grosor de 250 mm y barras de acero #4. En la figura 22 se muestra el escaneo y el procesamiento de imagen realizado en una porción del muro perimetral. En la figura 22(b), las barras de acero aparecen como aberturas en la imagen de ultrasonido, sin embargo, cuando la imagen es procesada, todas las aberturas son rellenadas a excepción de una (véase figura 22(c)). Este muro perimetral tenía una doble malla, por lo que es probable que el detector de metales solo haya detectado la malla más cercana a la cara de análisis y no la segunda malla. Por lo tanto, es probable que esta abertura en la figura 22(c) haya sido generada por una barra de acero de la malla profunda.
